**PROGRAM FOR EXPERIMENTAL INVESTIGATION OF FAILURE
PROGNOSIS OF HELICOPTER GEARBOXES**

**Northrop Research and Technology Center
3401 West Broadway
Hawthorne, Calif. 90250**

August 1976

Final Report

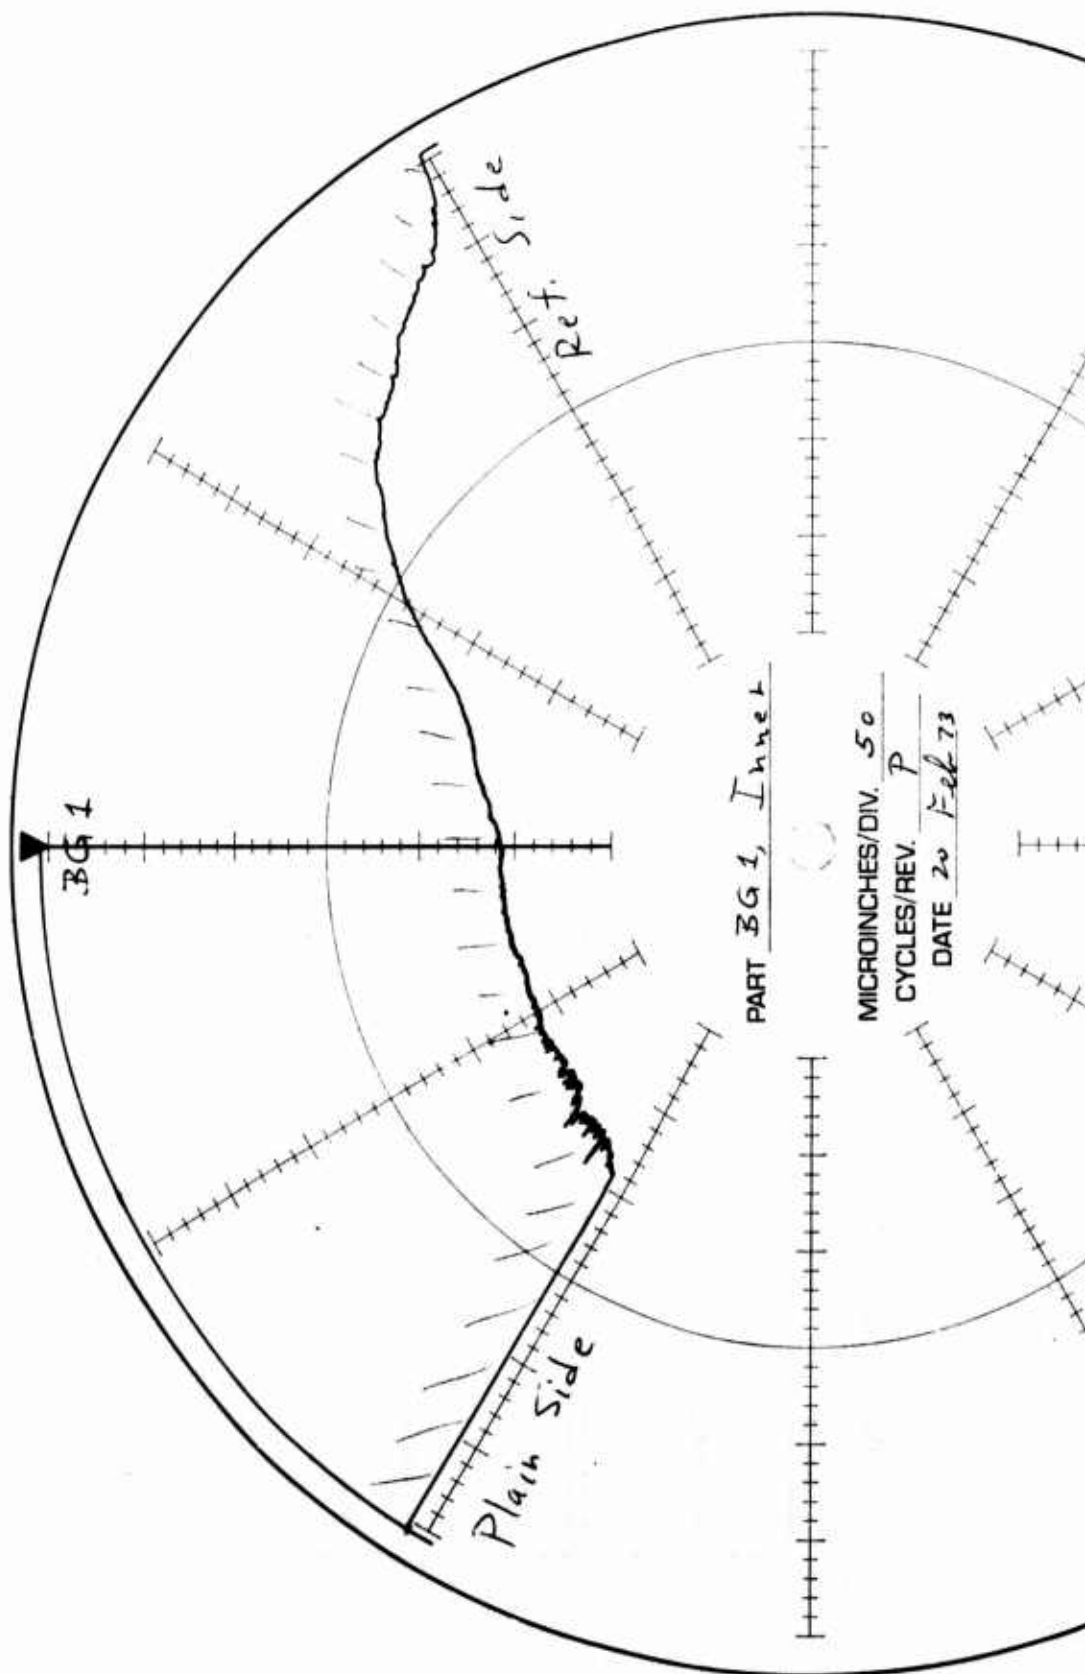
Figure 128. BG-1 Cross-Groove Profile at Zero Test Hours.

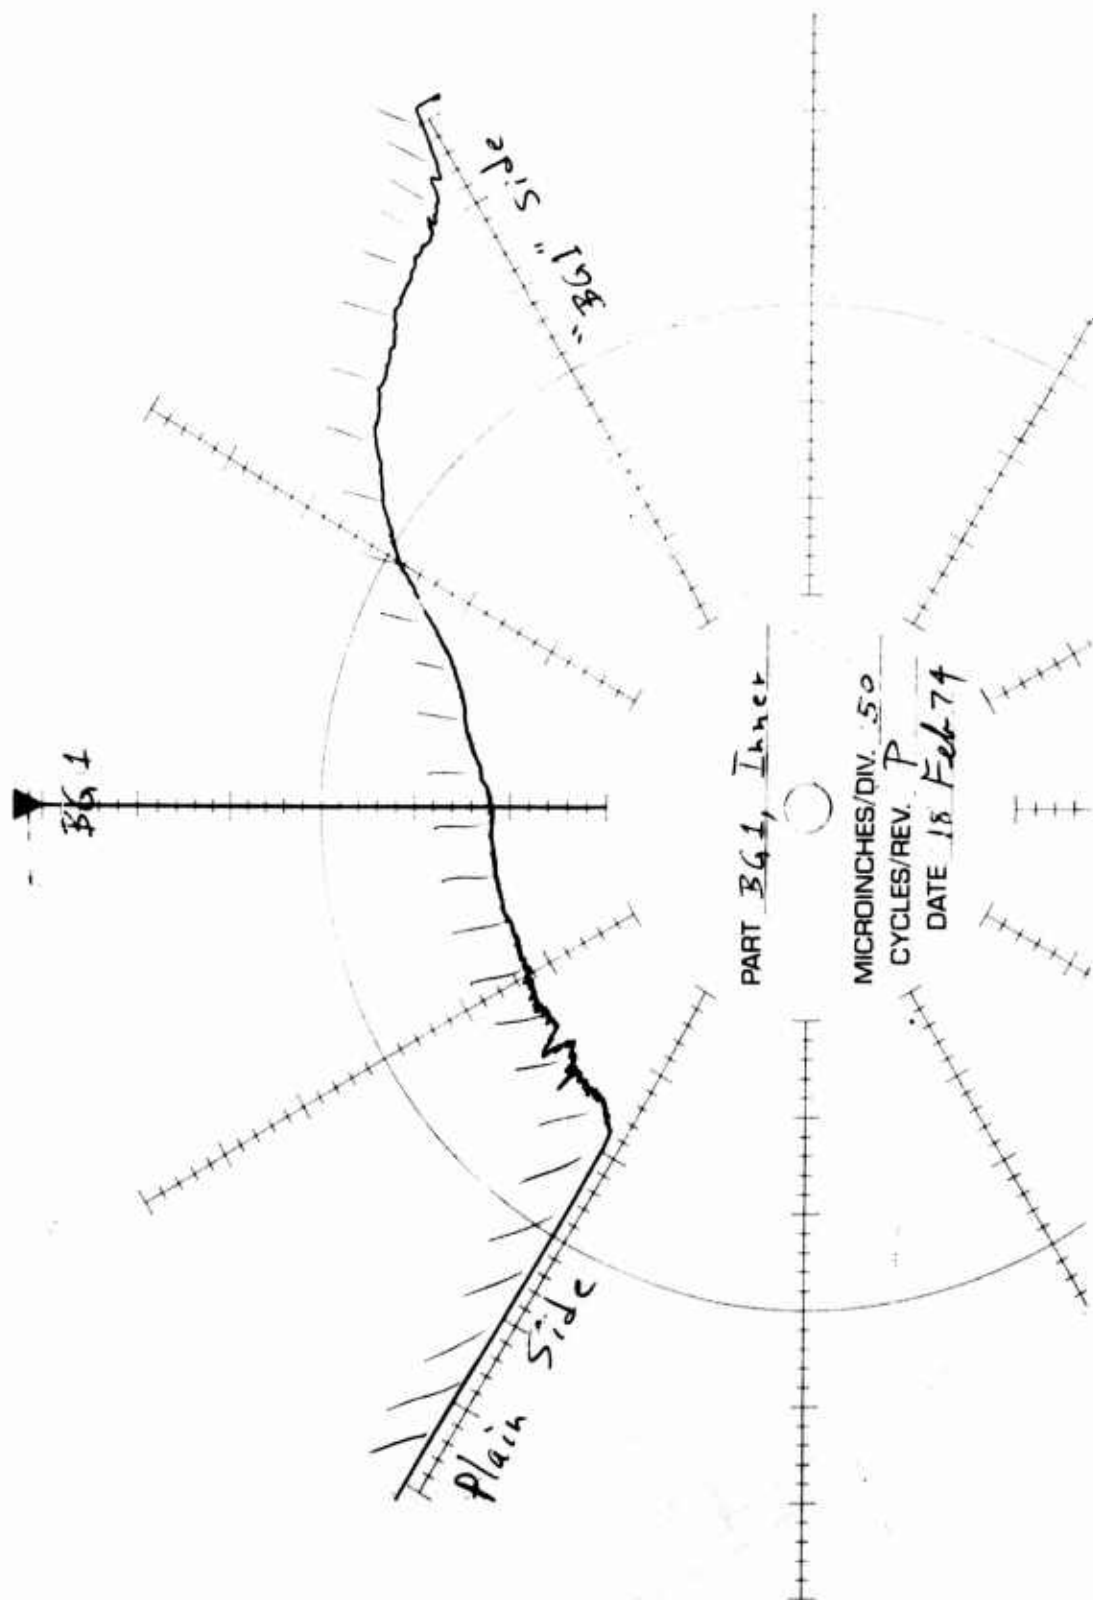
Figure 129. BG-1 Cross-Groove Profile at 1000 Test Hours.

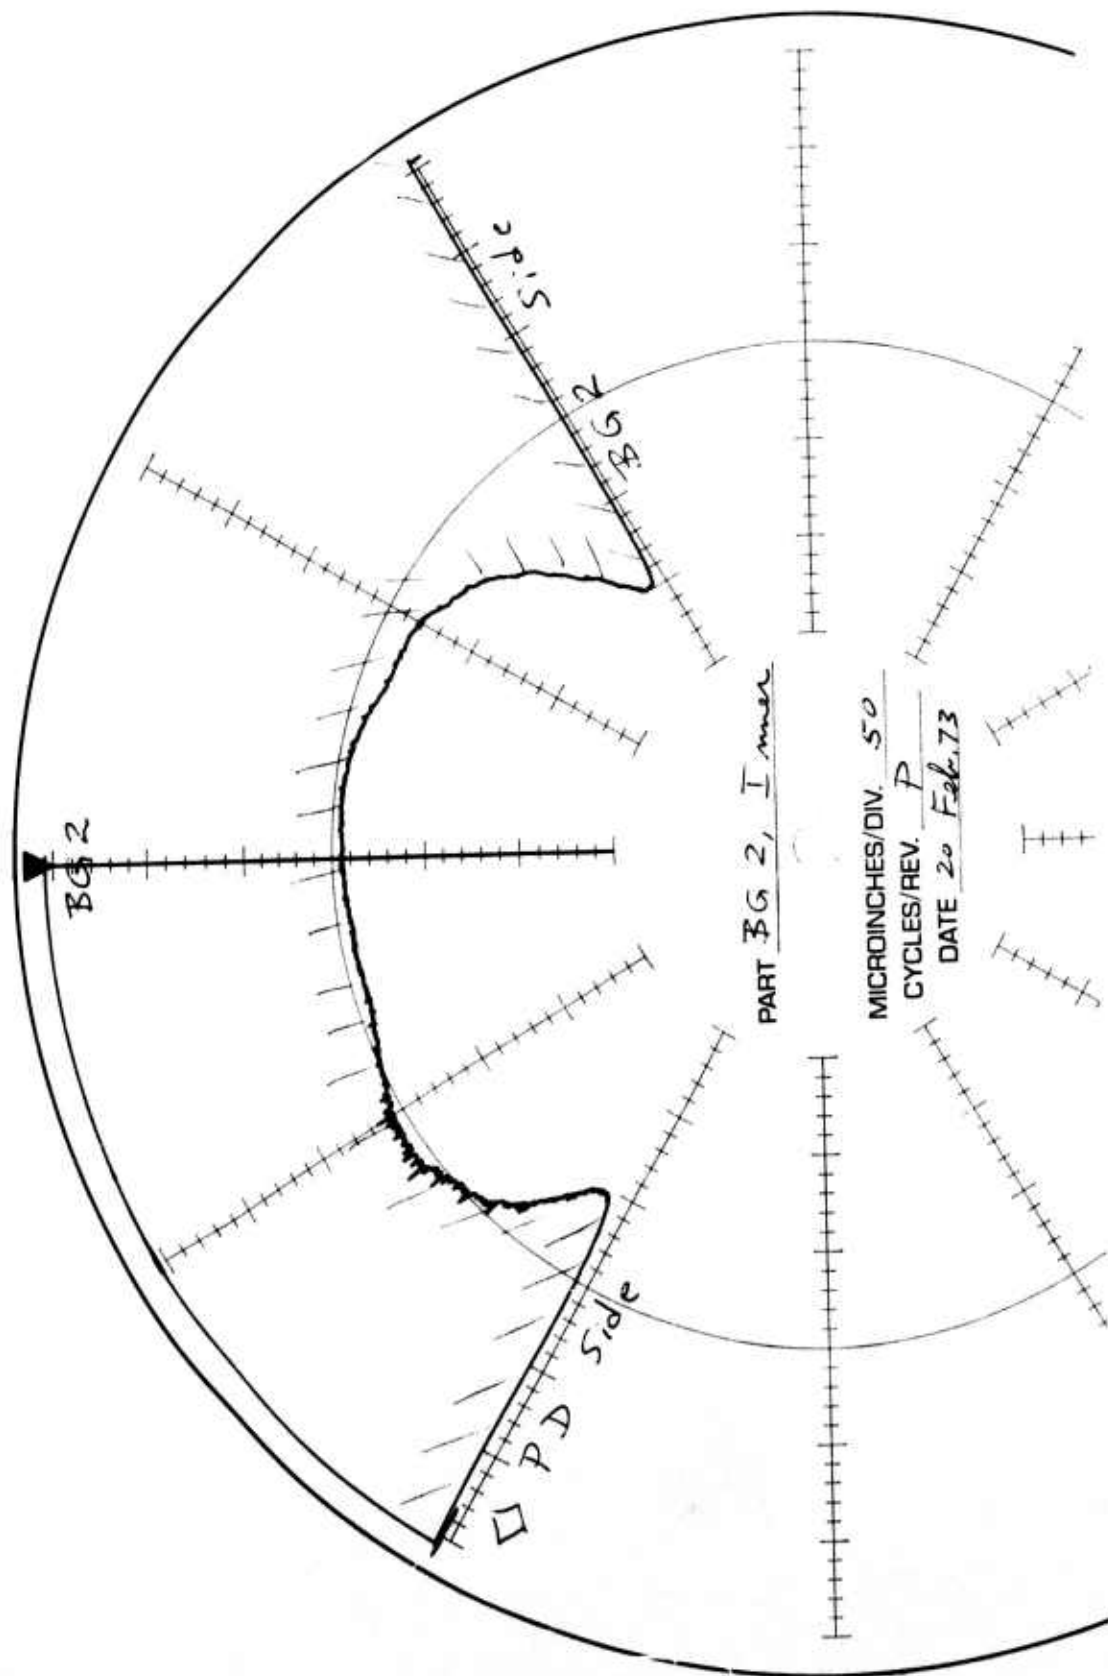
Figure 130. BG-2 Cross-Groove Profile at Zero Test Hours.

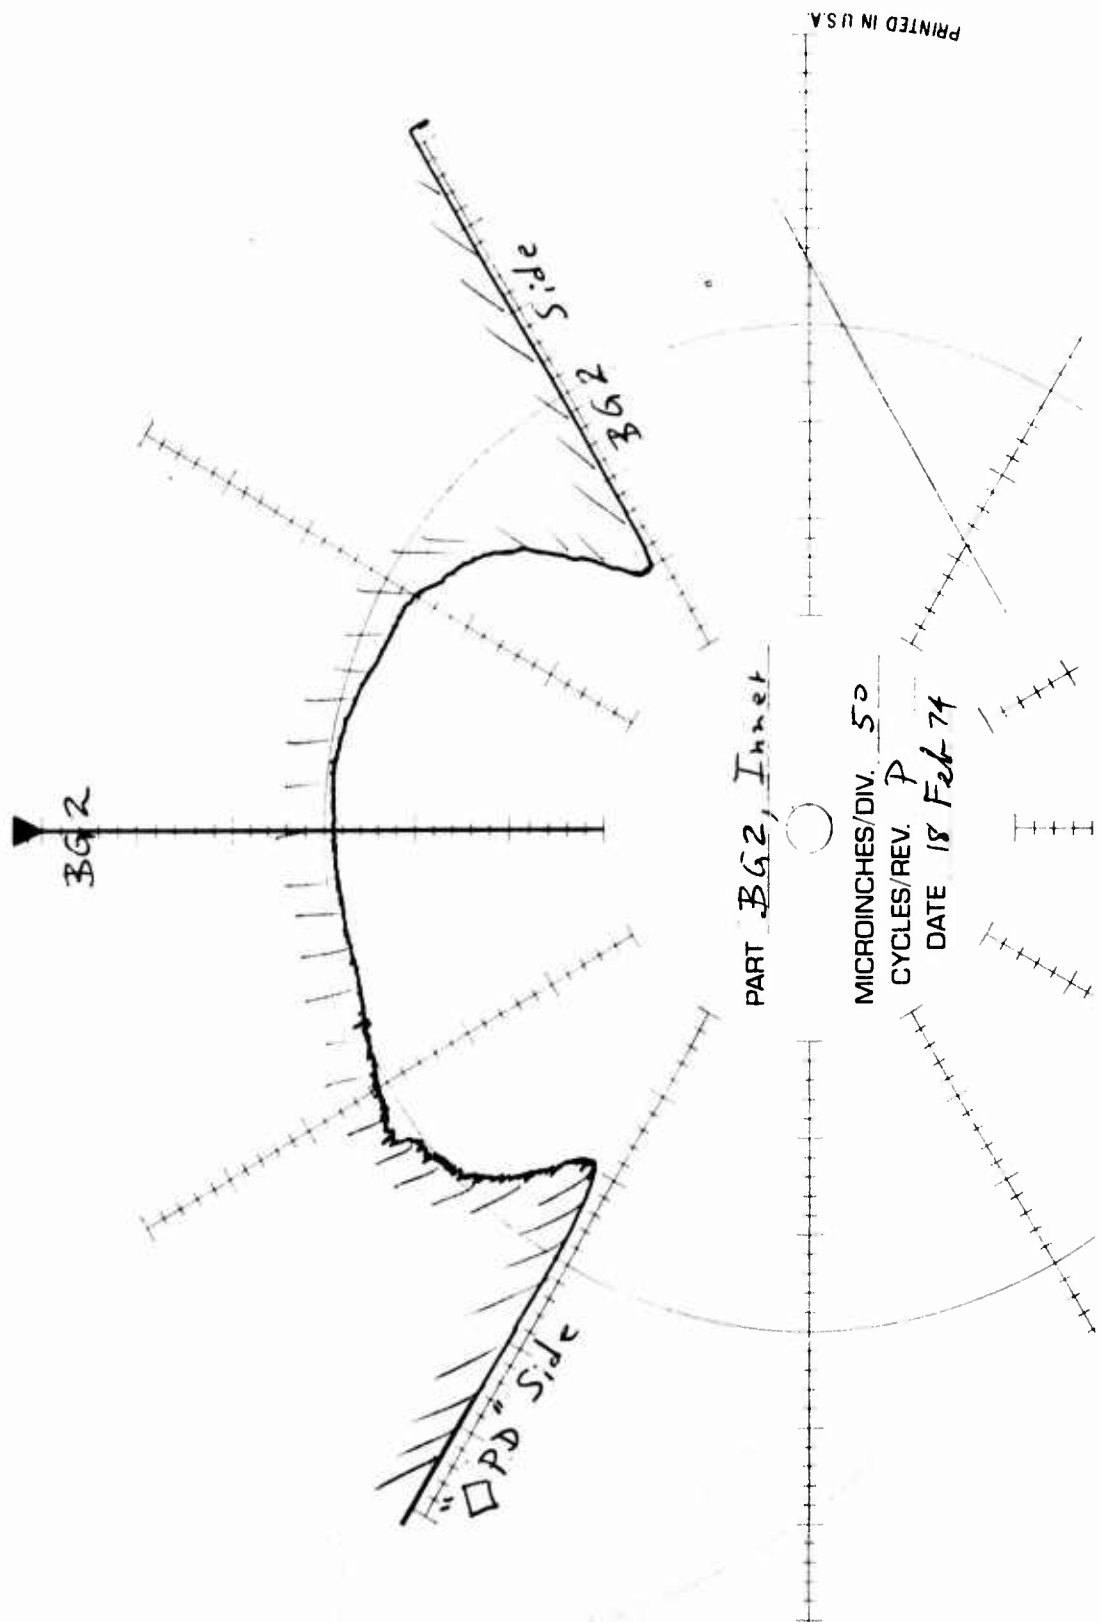
Figure 131. BG-2 Cross-Groove Profile at 1000 Test Hours.

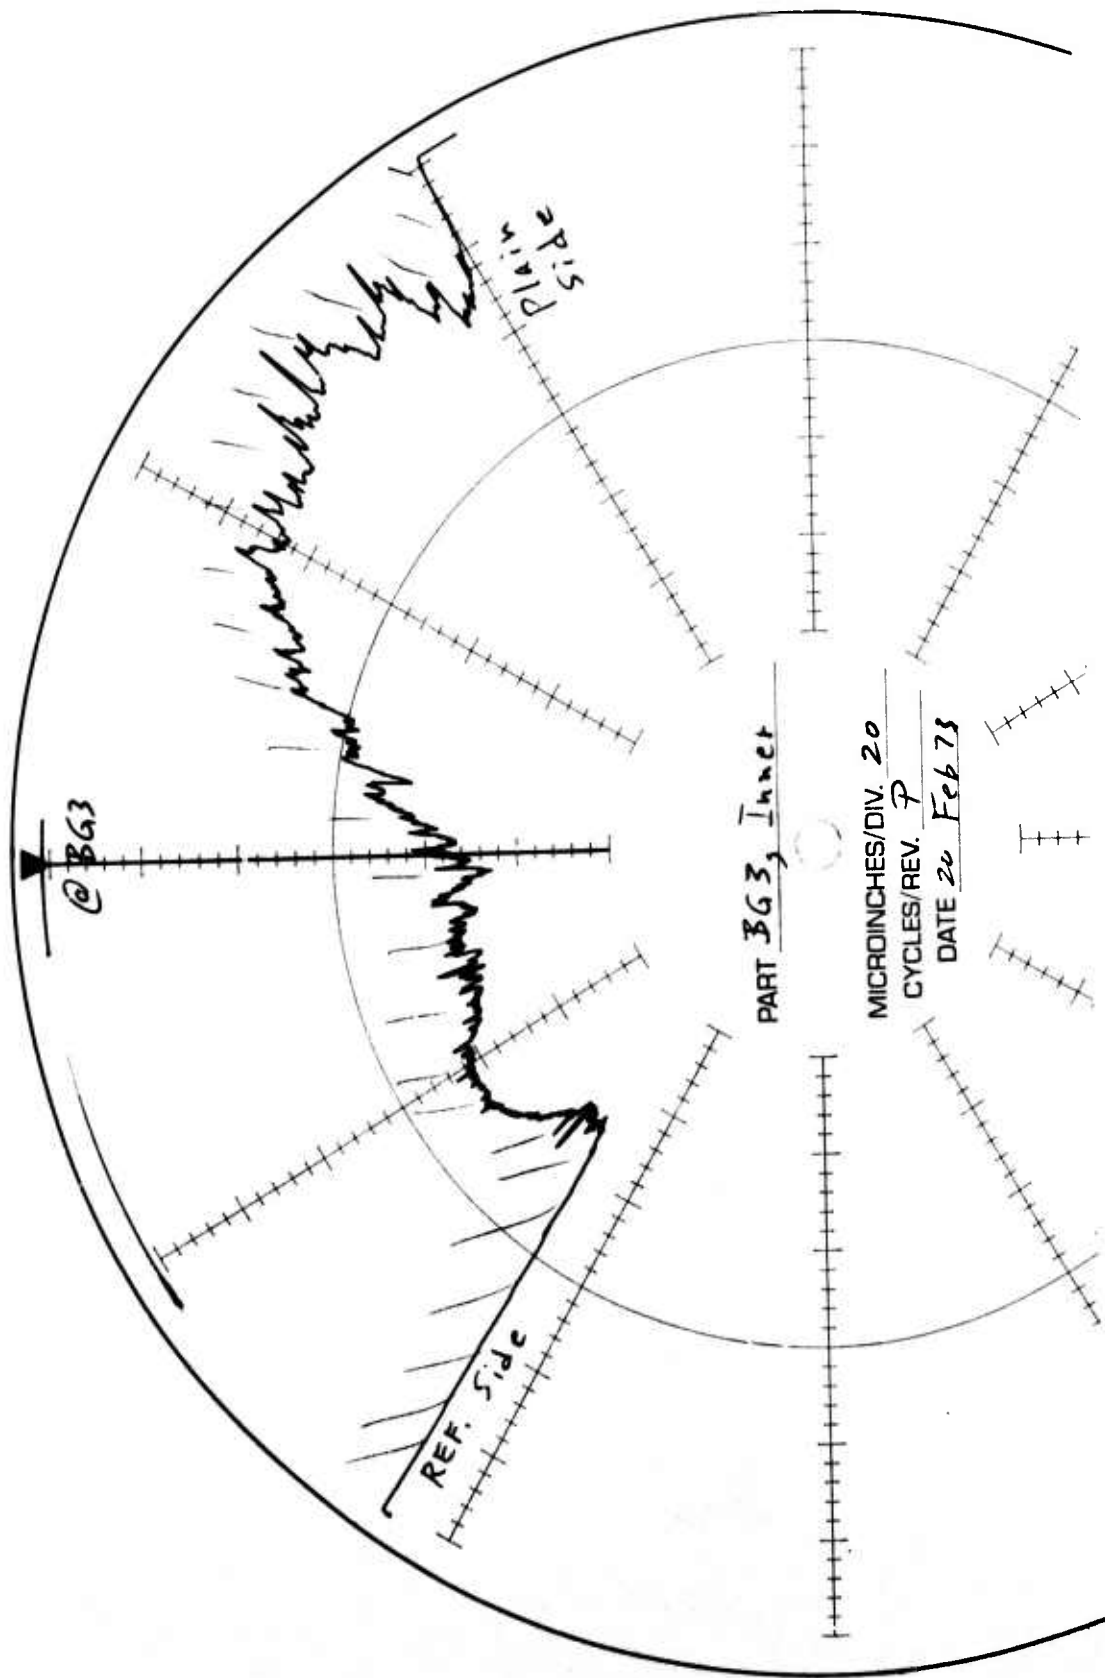
Figure 132. BG-3 Cross-Groove Profile at Zero Test Hours.

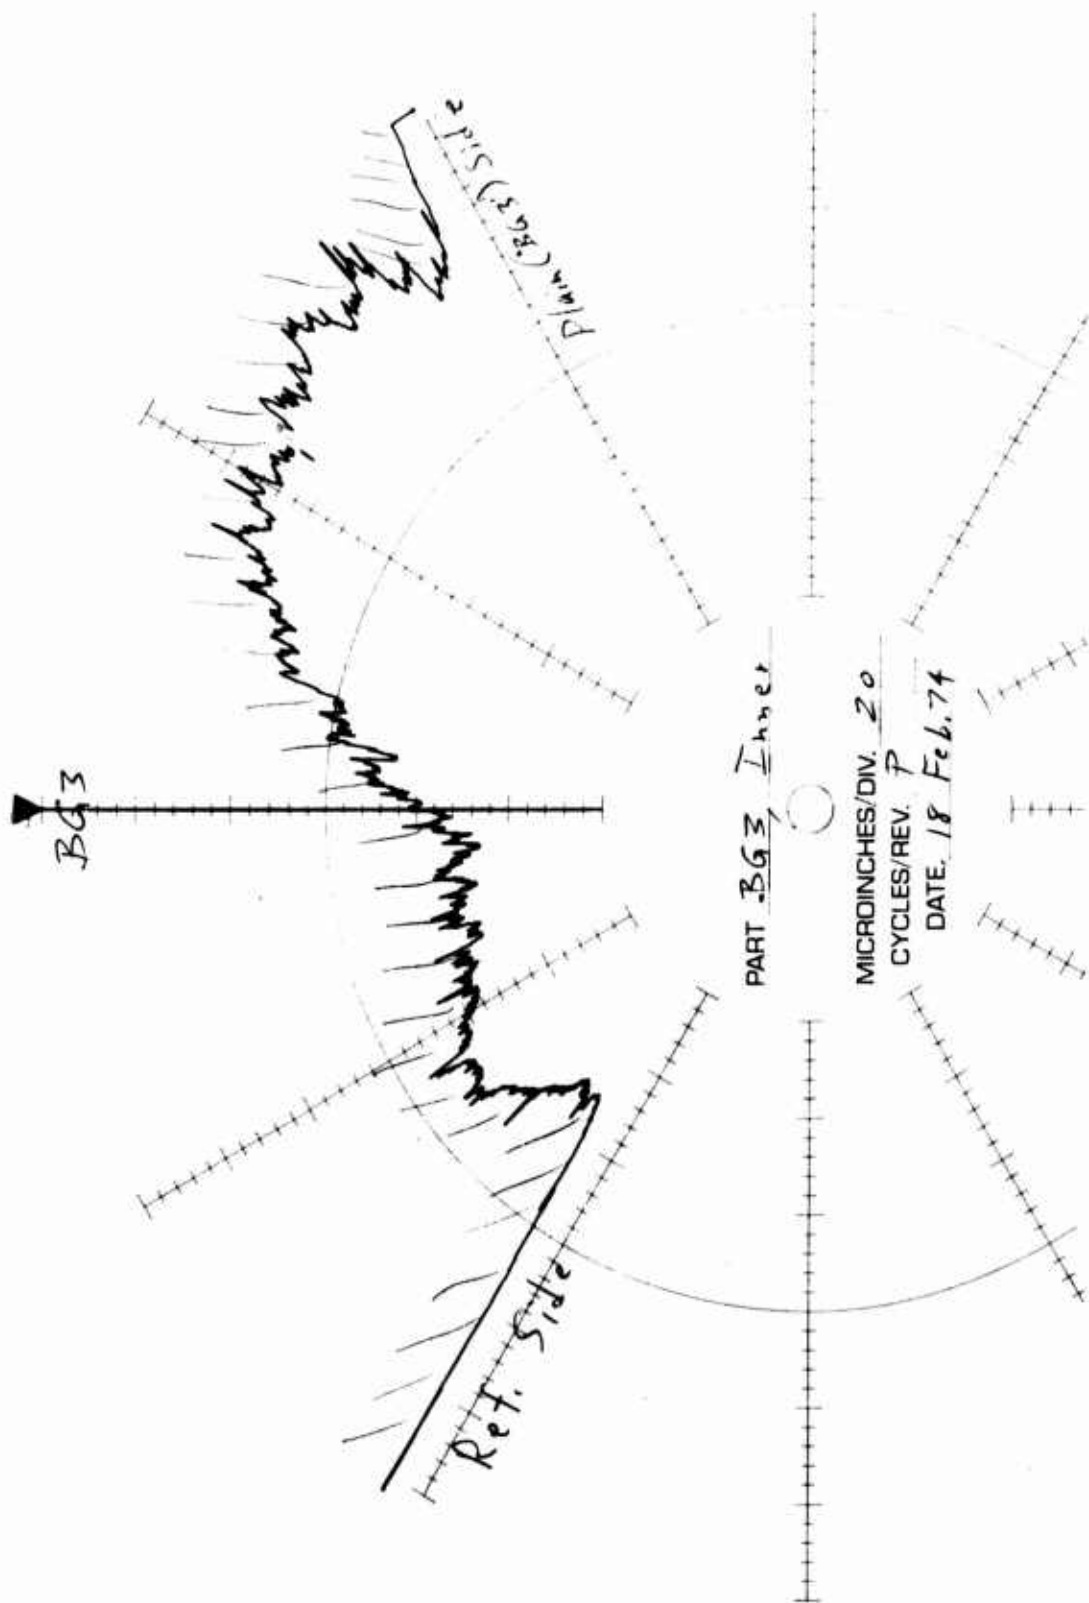
Figure 133. BG-3 Cross-Groove Profile at 1000 Test Hours.

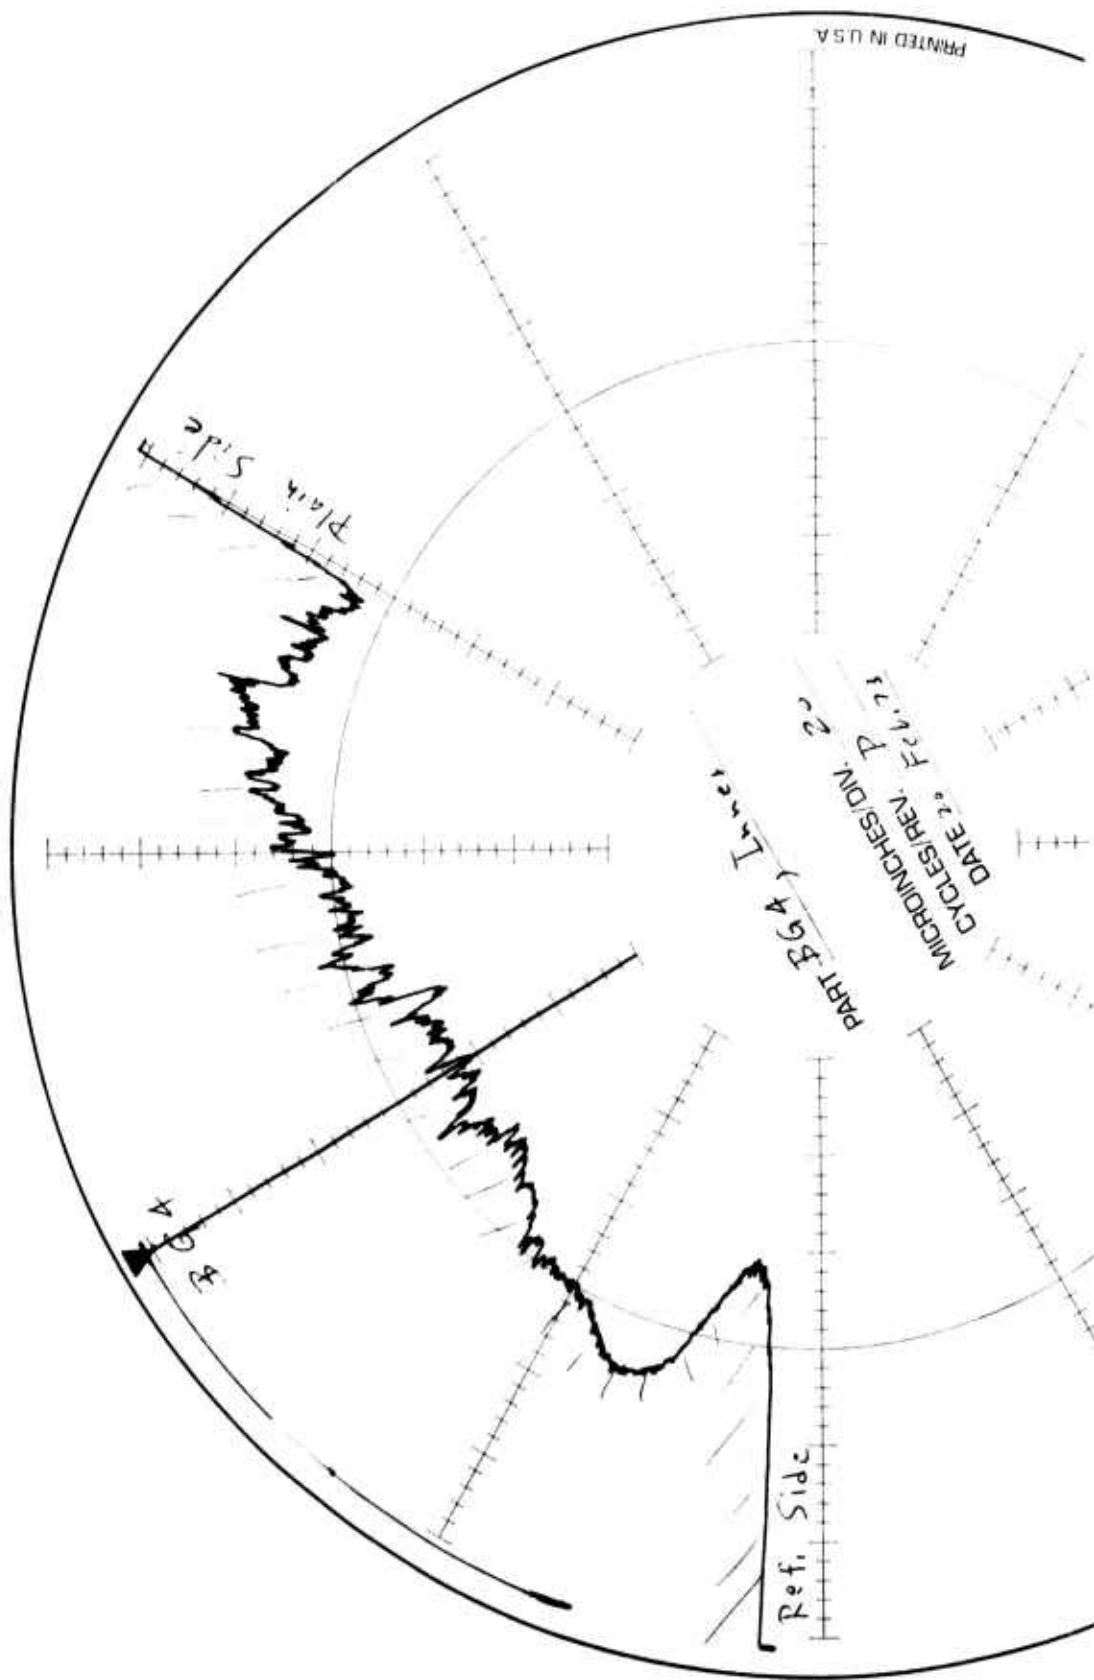
Figure 134. BG-4 Cross-Groove Profile at Zero Test Hours.

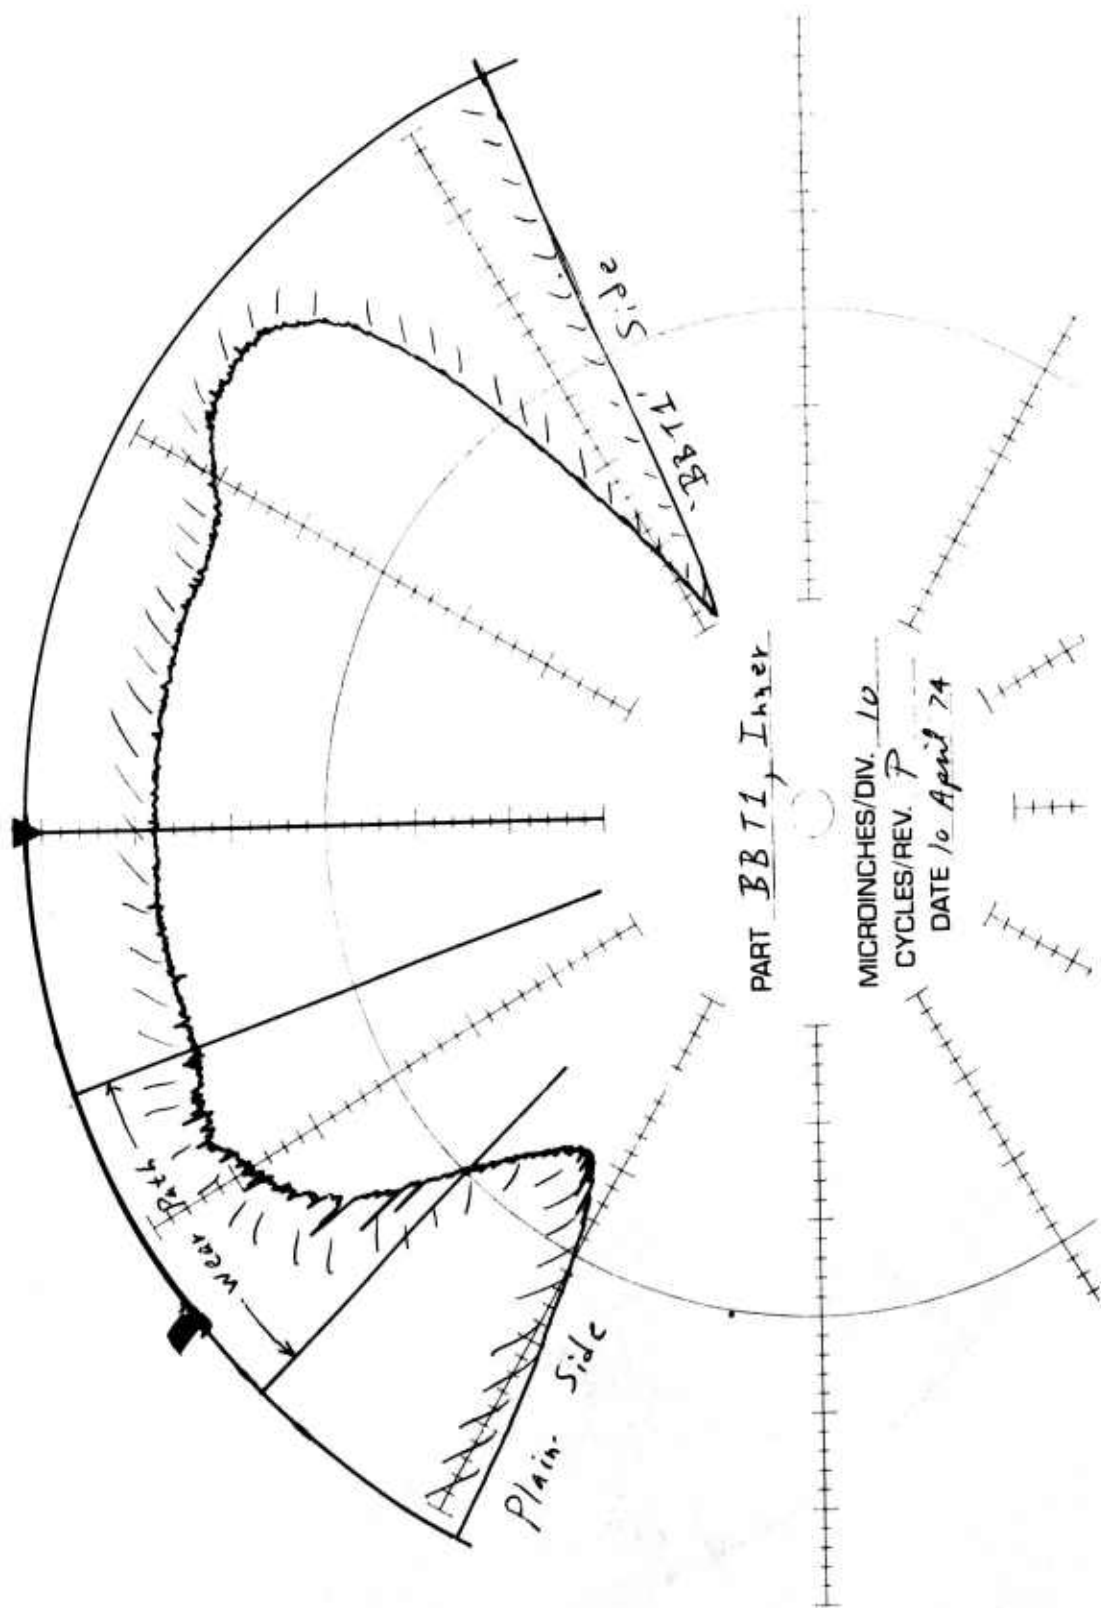
Figure 141. BBT-1 Cross-Groove Profile at Zero Test Hours.

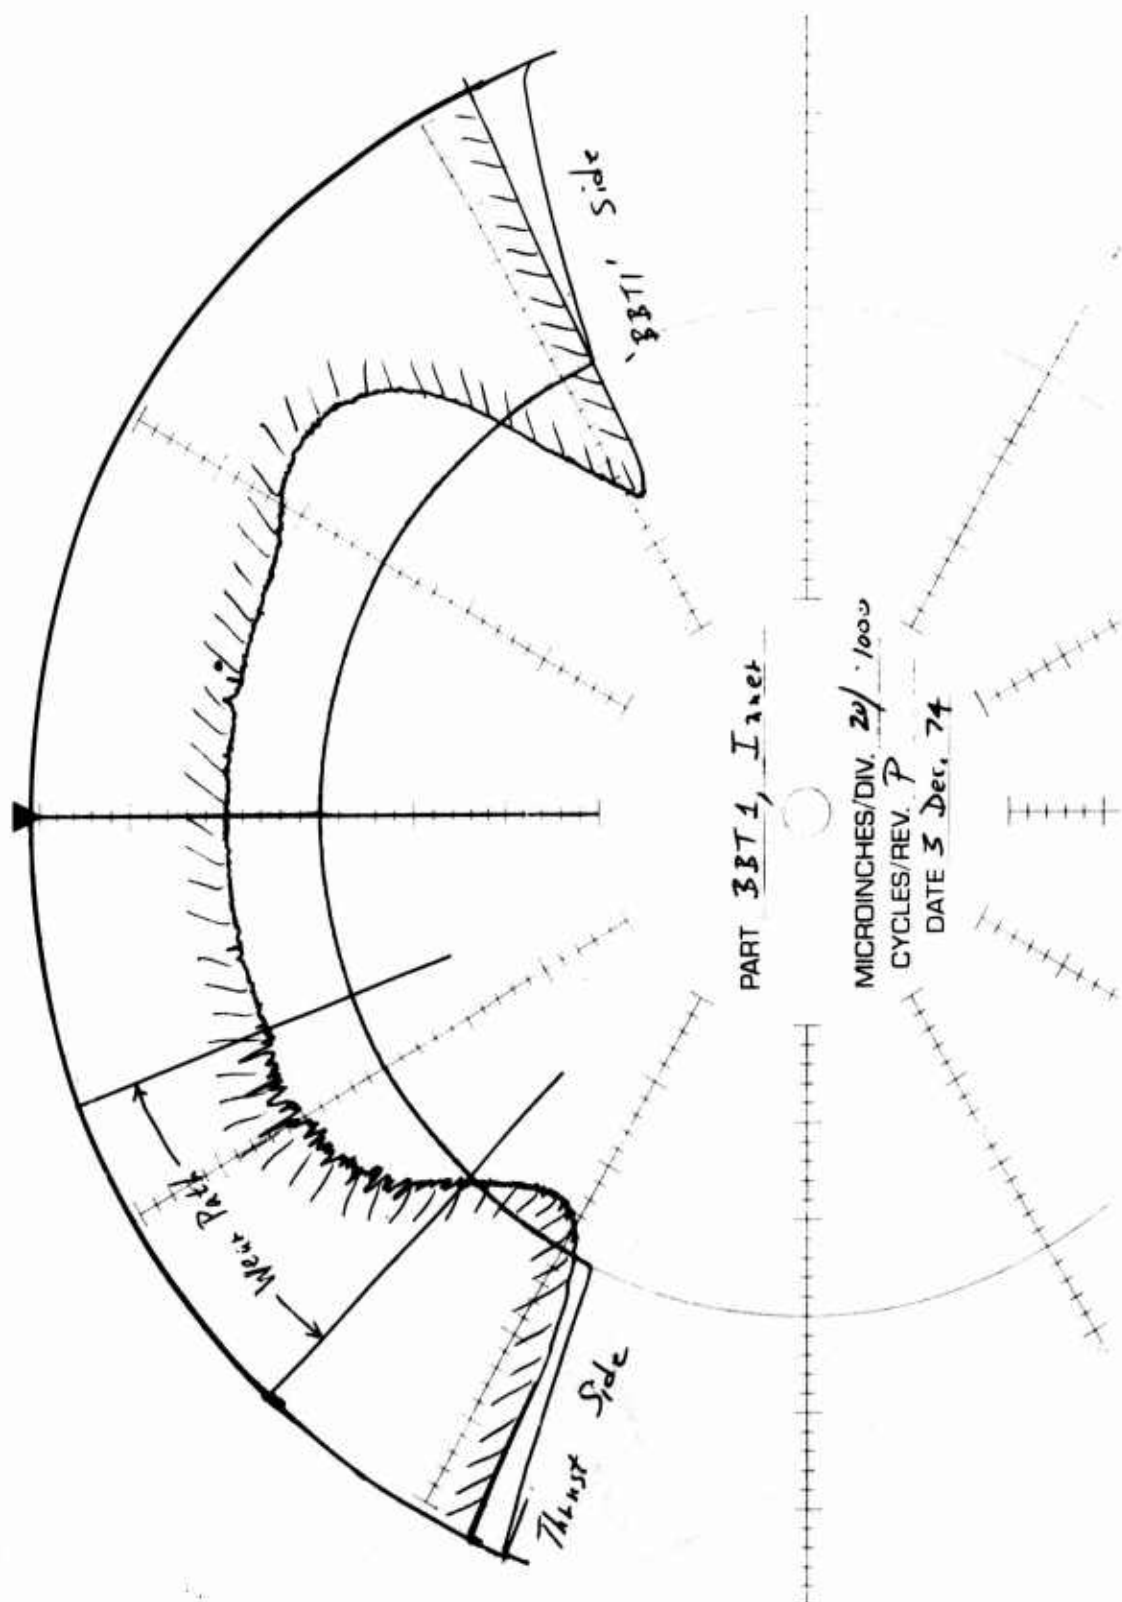
Figure 143. BBT-1 Cross-Groove Profile at 1022 Test Hours.

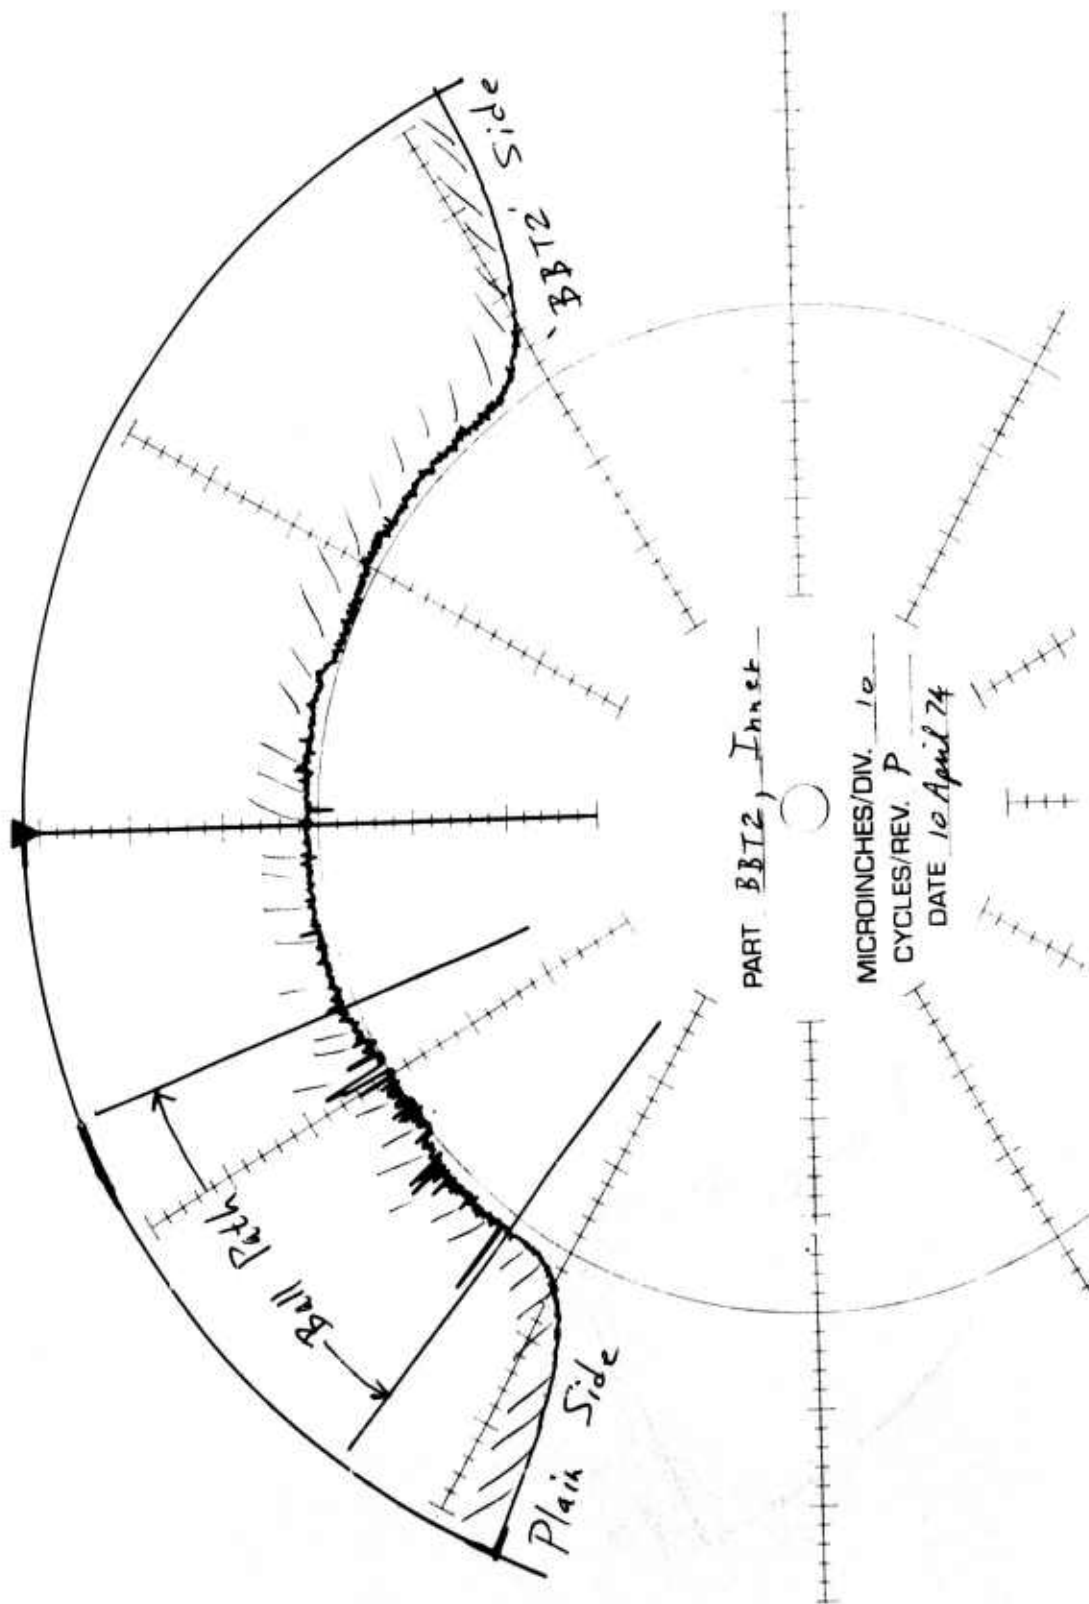
Figure 144. BBT-2 Cross-Groove Profile at Zero Test Hours.

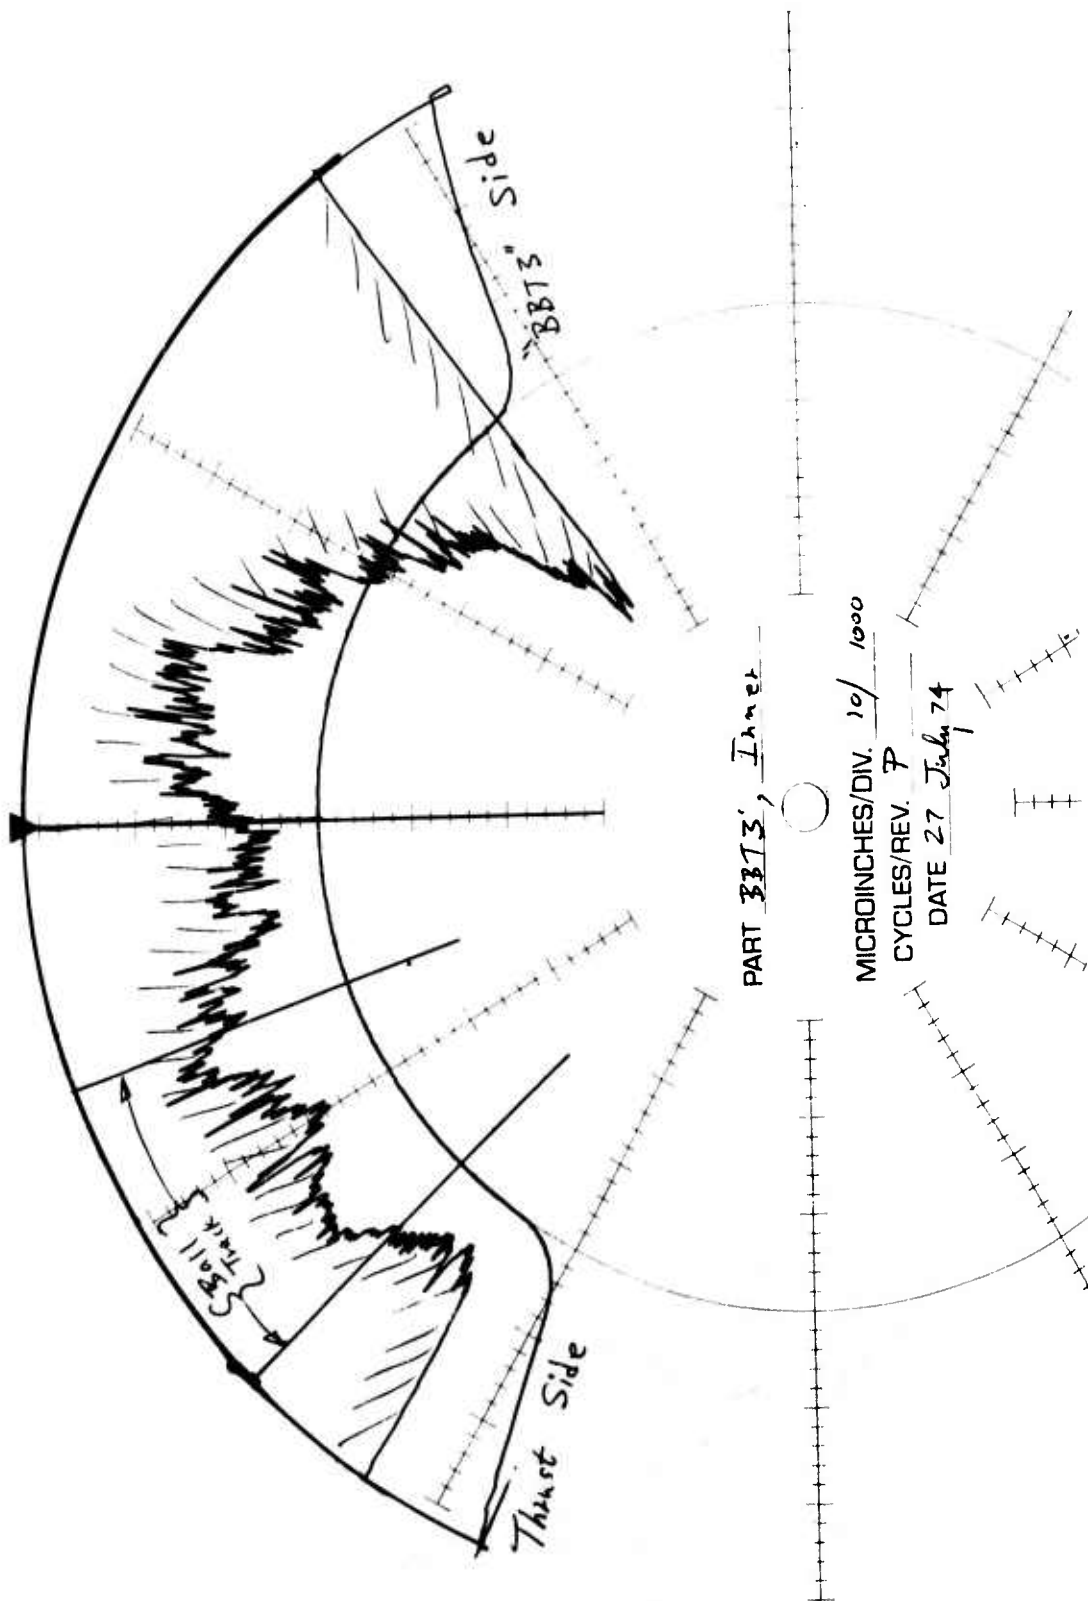
Figure 148. BBT-3 Cross-Groove Profile at 407 Test Hours.

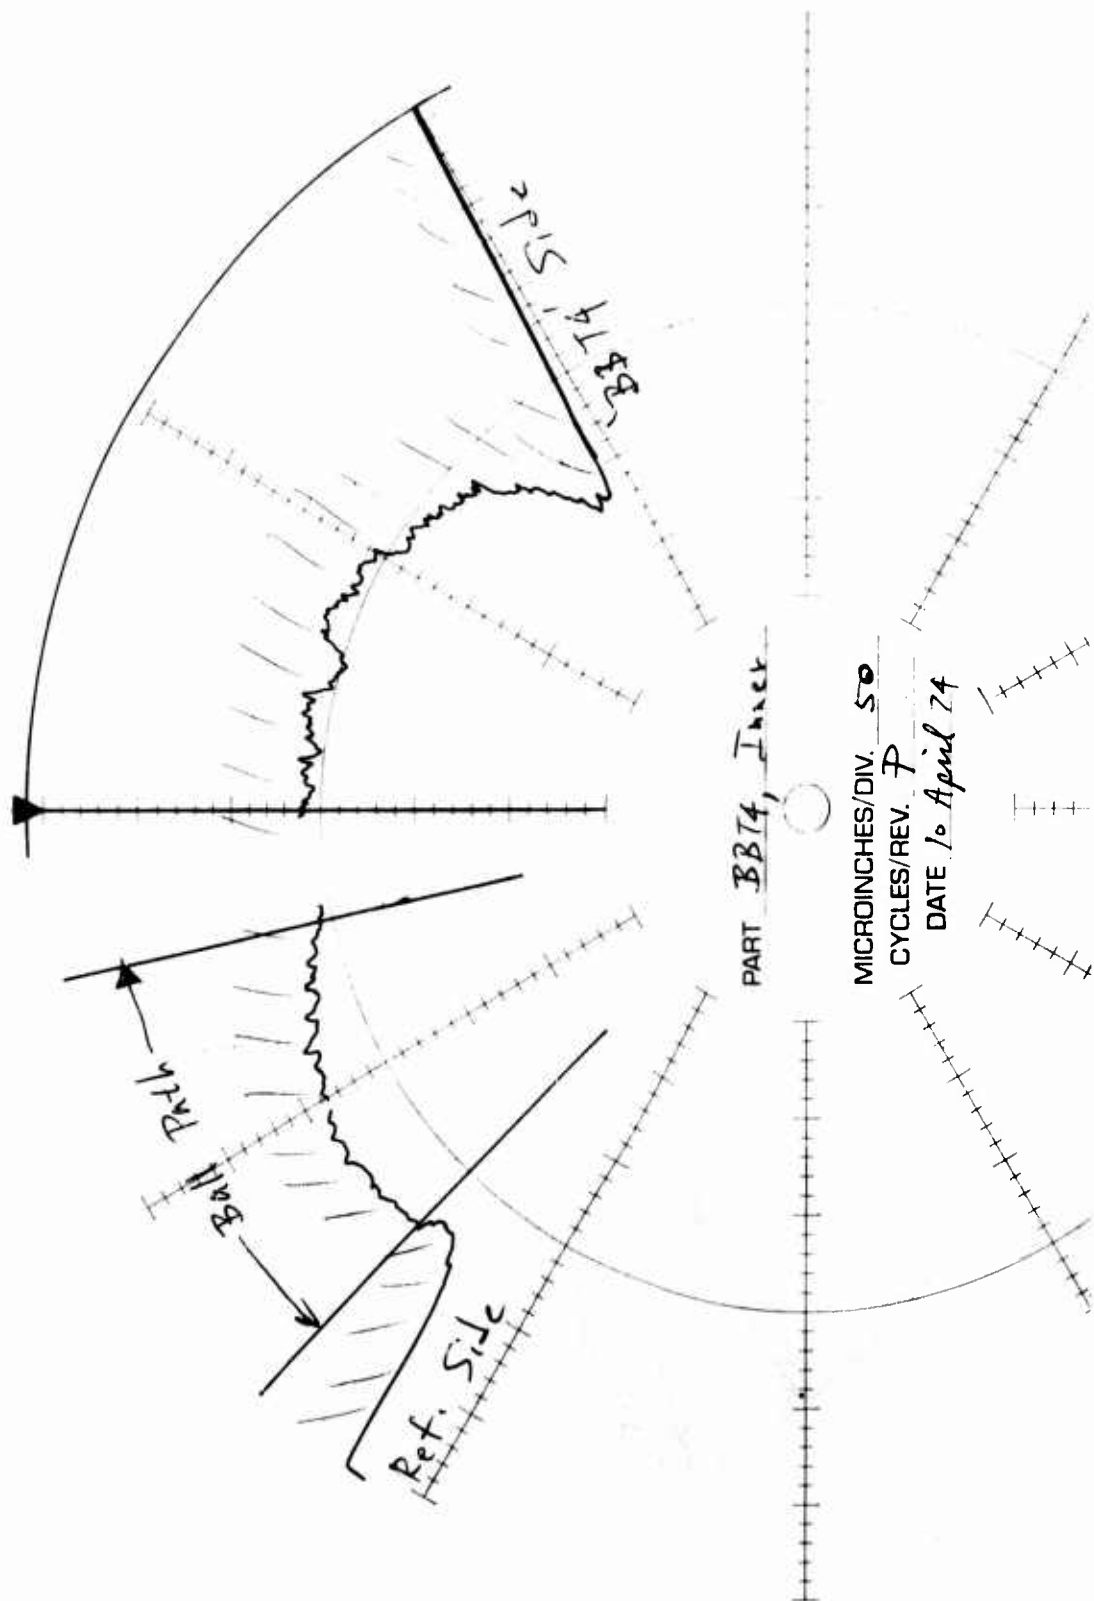
Figure 150. BBT-4 Cross-Groove Profile at Zero Test Hours.

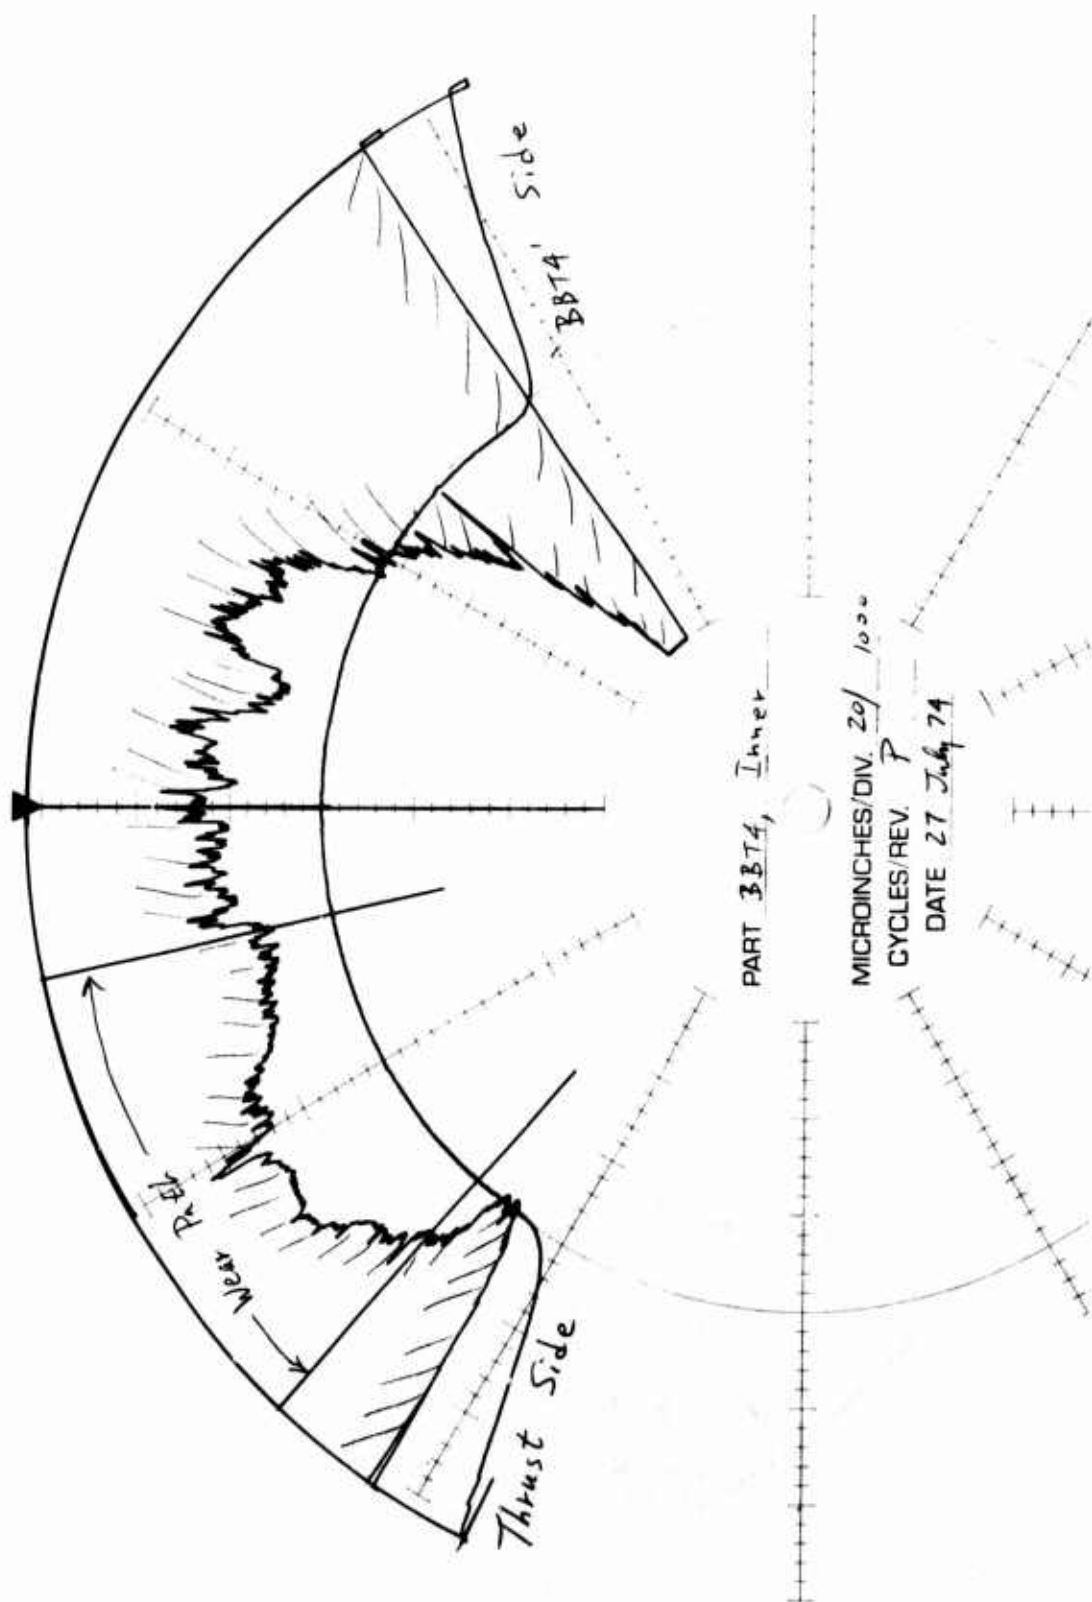
Figure 151. BBT-4 Cross-Groove Profile at 407 Test Hours.
